S.6 Chassis Study Group Information Report: 2002-1

Road Chemical Induced Corrosion

Developed by the Technology & Maintenance Council's (TMC)
Ice-Clearing Chemical Induced Corrosion Task Force
Under the Auspices of the S.6 Chassis Study Group

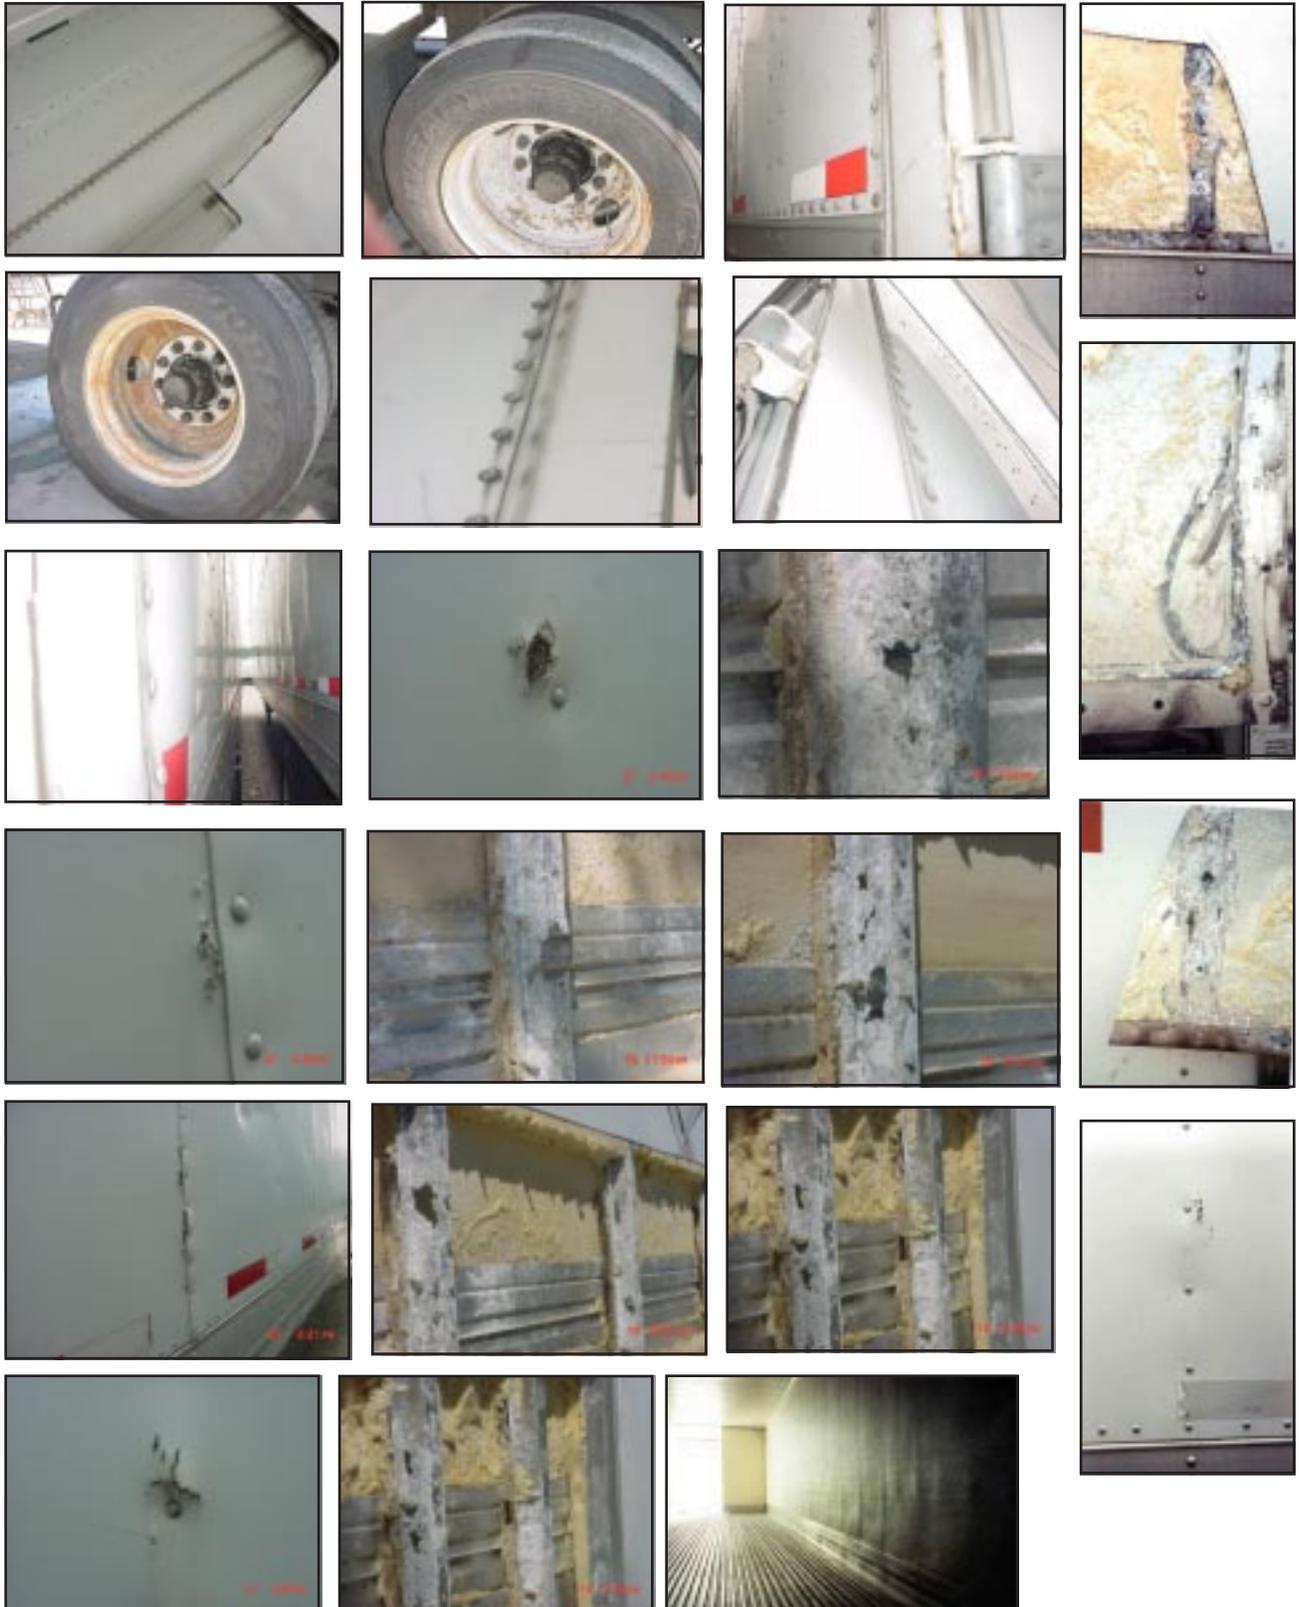
The following photos are examples of corrosion caused by new road ice clearing chemicals as described in this information report. What also follows are reprints from TMC's *Maintenance Manager Magazine* and *The Trailblazer*, also describing the problem.
